DTNSRDC-82/028

4. TITLE (and Subtitle) DETERMINATION OF FATIGUE DAMAGE IN CORROSION- FATIGUED A1-2024-T4 AND CYCLED Ti-6Al-4V ALLOYS		5. TYPE OF REPORT & PERIOD COVERED Research and Development

6. PERFORMING ORG. REPORT NUMBER
7. AUTHOR(s) T. Takemoto, K.L. Jing, T. Tsakalakos and S. Weissmann (Rutgers University) and I. R. Kramer (DTNSRDC)		8. CONTRACT OR GRANT NUMBER(s) N00600-77-C-1134

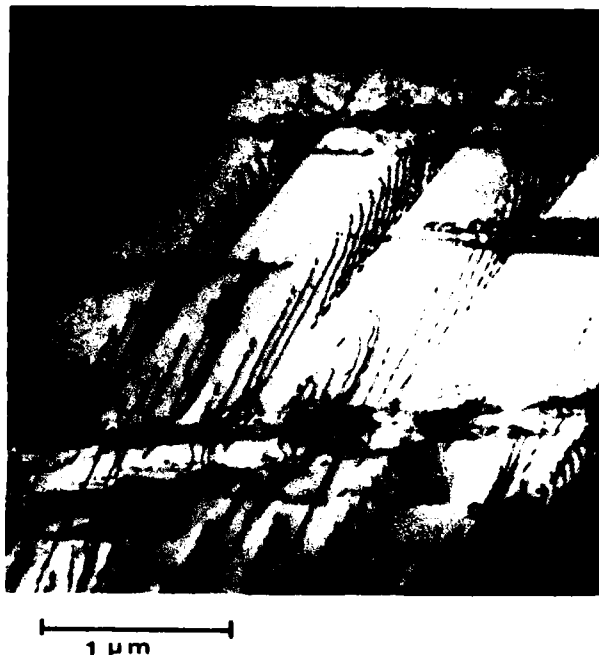
Figure 31. Typical Planar Dislocation Configuration of Surface Layer, Induced by Uniaxial Tensile Deformation; $\epsilon_p = 2.7$ pct.
